PERSONAL PLANE SERVICES LTD

Service Bulletin No. 2

Stampe SV4C Aircraft

SERVICE BULLETIN NO. 3.

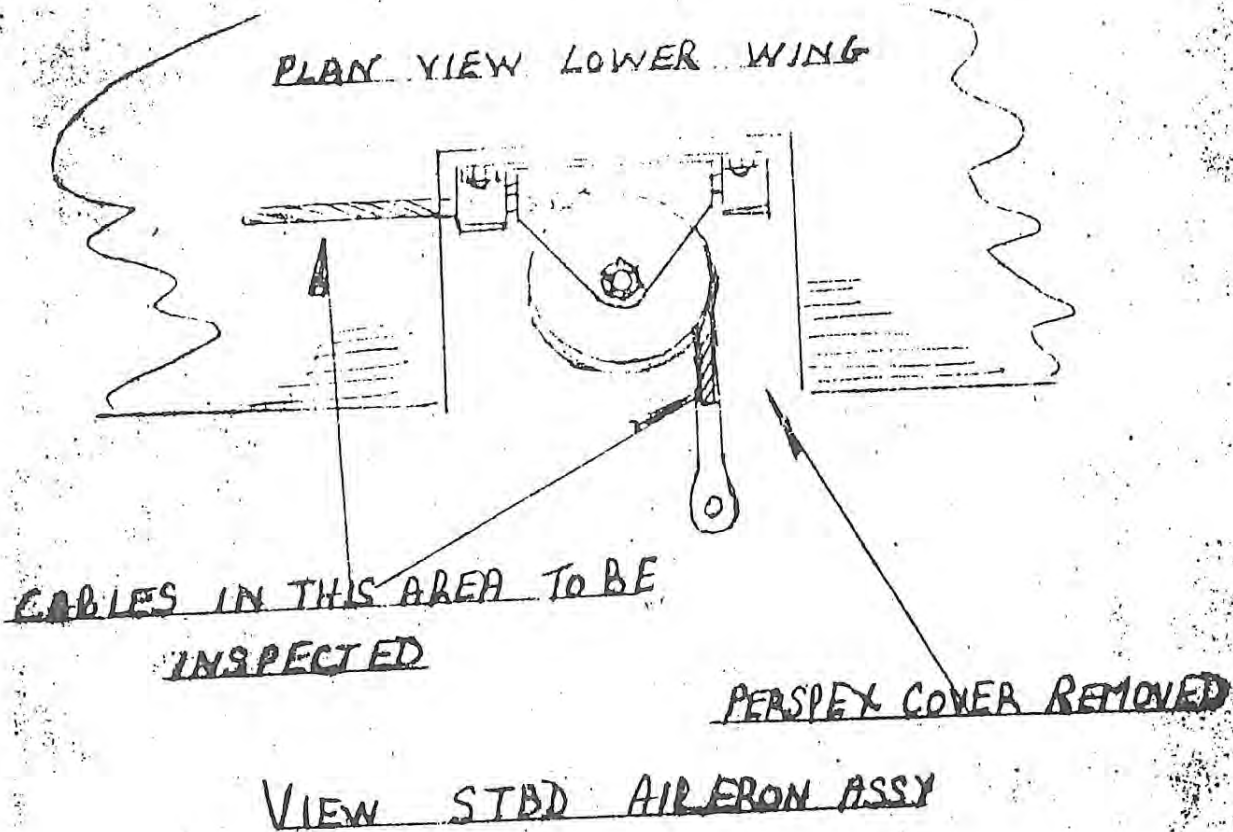
Every 100 hours it is essential to slip the aileron cables at the outer pulleys and inspect for fraying. It is necessary to unwind the cables in the area where they pass over the pulleys as fraying takes place in the inner strands. The pulleys must articulate freely and must be free of grooving.

LIFT OUT CABLE AND UNWIND TO INSPECT INSIDE

Cables should be 3/32" dia. to Spec MIL-C-1511 of 7 x 7 construction. Care must be taken not to over tension these cables or the aileron connecting wires.
